ASSESMENT ON CULTURAL AND ARTISTIC HERITAGE IN BETHLEHM May 14th 2002

On May 14th, 2002, an assessment of damages in the Church of Nativity complex has been carried out. From the assessment following damages emerged, divided by areas:

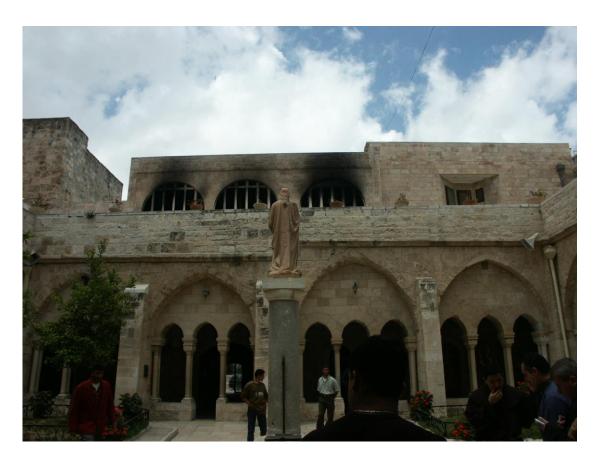
The hall is in the northwest area of the complex. The bearing structure of the hall is in reinforced concrete. There is also a kitchen. Total surface is 150 m2. Damages have been caused by a fire and by bullets. Pavement, plaster, frames, doors, electric system, lighting system and painting have suffered damages.

External stone façade is blackened by smoke.

Hall façade of Franciscan Convent

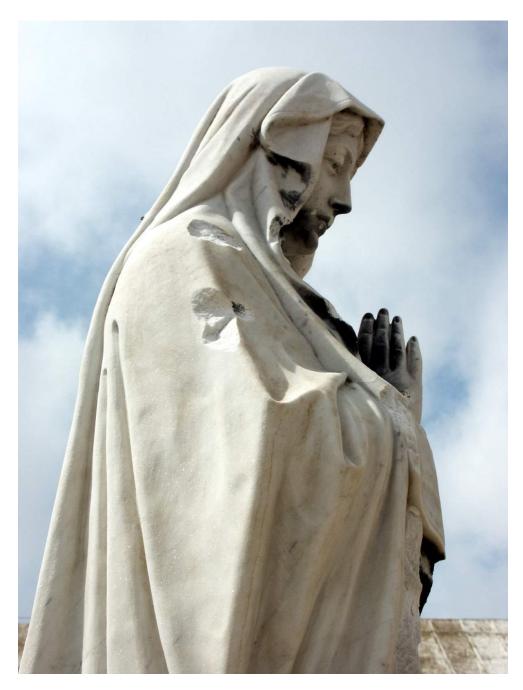
The courtyard forms the centerpiece of the Franciscan monastery, the oldest in the complex, dating back at least at Crusaders time. Over a basement on the façade of the church, the statue of the Madonna has been shot by several bullets in various spots. The marble statue goes back to 1908. The bullets damaged the statue in five spots on the upper part, creating a black patina around the shots. Part of the marble came off.

Statue on St. Catherina Church façade

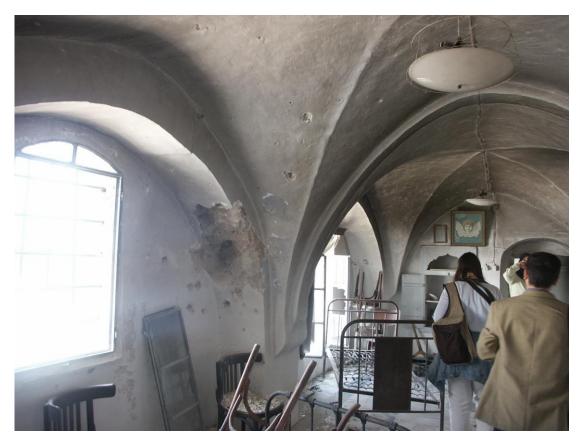
In medium floor the damage is light, just some problems at the electric system and broken glasses in northern and southern windows and glass door.

A double cross-vaulted room suffered a missile shot that damaged window frames. The missile hit the starting of the arch in the cross vault and caused a 20-cm hole. Splinters damaged also the plaster and painting.

Greek convent: room in medium floor

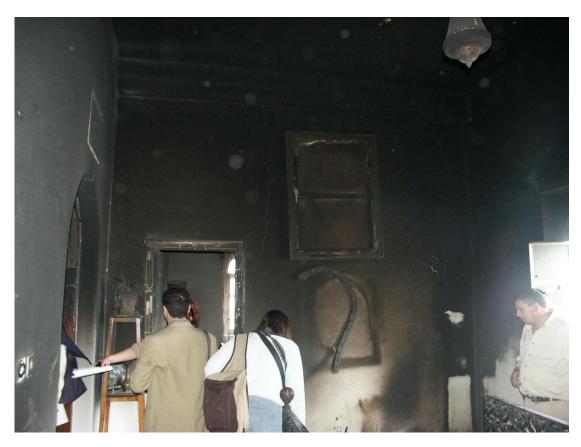
Three rooms and one staircase in the upper level caught fire. Two are in severe conditions, one medium. Damages by fire did not hit the structure and concerned wooden doors, handrails, plaster, pavement, windows, paint and varnish. In one of the room an ancient painting and furniture have been damaged.

Greek convent: room in upper floor

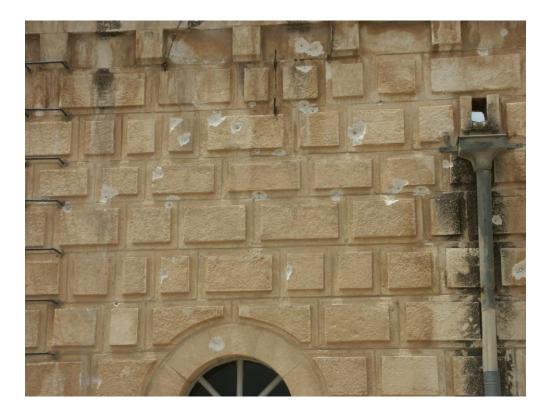
External southern and eastern façades of the tower suffered shots creating 3 to 5 cm deep holes with 3 to 10 cm diameters. The shots are scattered all over the facades. In the northern-eastern angle of the tower, one of the stones shaping a porthole is damaged.

Greek convent external façade

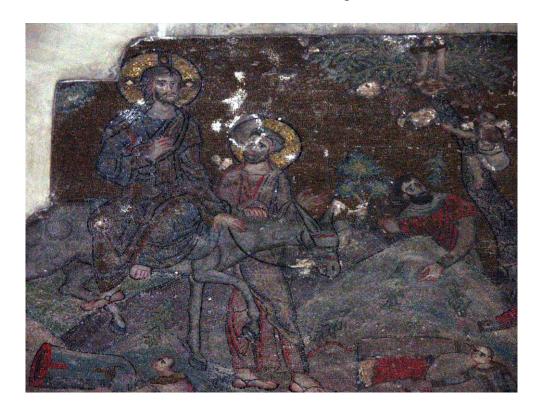
It is very difficult to assess damages suffered by Crusaders mosaics without drawing nearer. The church guardians showed us two points that have been hit. The first one is in the central nave, in the north wall, where one of the angels looking towards the grotto has been shot by a bullet, which took off part of the mosaic surface. The other damaged mosaic is the "Triumphal Entry of Jesus" in south transept. Bullets shot the mosaic between the head of Christ and the head of an apostle.

Church of the Nativity transept mosaic

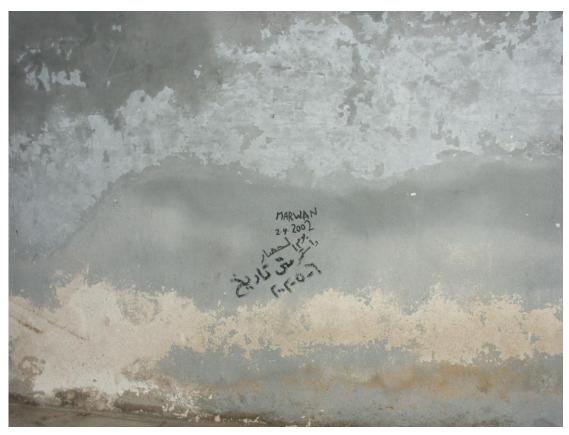
The long staying of so many people inside the church caused dirt and various damages to the walls.

Recent graffiti on the wall of the Church of the Nativity

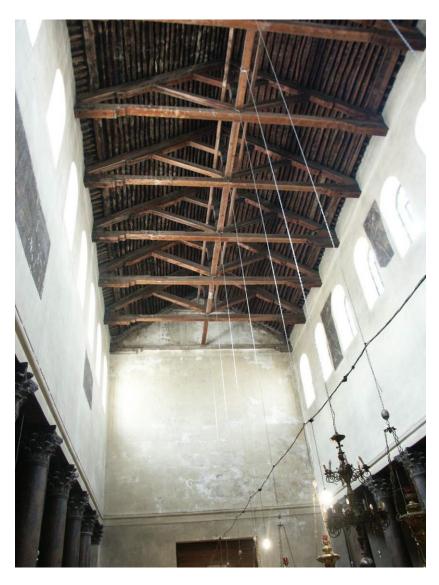
Roof in the Church of the Nativity

Several bullets shot the lead roof. The roof, due to its severe condition, has been covered by sheets of liquid tar.

As already state it has not been possible, during the present assessment, to draw up near some of the areas in the Church of the Nativity to check their conditions in a satisfactory way. This concerns especially the roof and the wall mosaics.

Moreover some of the decoration of the Church (such as the mosaics over the walls and the encaustic paintings over the columns) need a careful check done by professionals in the specific field to verify if some damages are not visible at a glance. We urge the importance to conduct an activity of monitoring and control, also with the help of simple tools, in these areas.

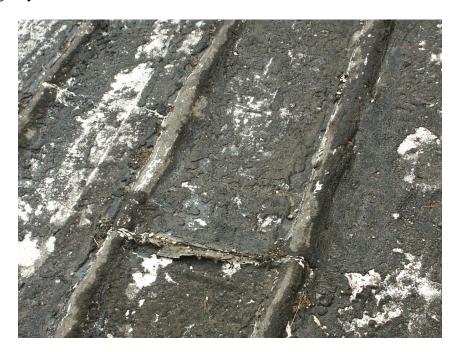
The assessment witnesses the severe vulnerability of the site. The Church of the Nativity has a priceless value both historically than religiously. It is now at risk of damages caused by geophysical and geo chemical activities, weather phenomena, human activities such as military actions, fires, site use.

Detail of damages on the roof of the Church of the Nativity

It is necessary to safeguard the Church of the Nativity and to prevent further damages by emergency interventions.

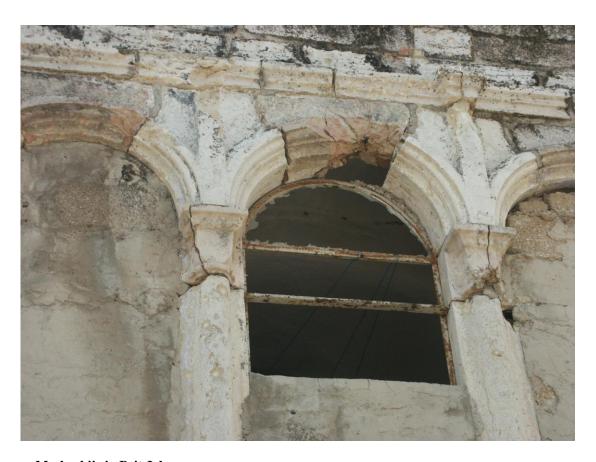
Mashrabije in Beit Jala

It is situated in a building in the old city of Beit Jala, in front of the Gilo settlement. It is very particular in its kind. It is composed by three arches in the front façade and one arch in each side façade. Its state of conservation is very bad. It supported damages in various parts by bullet shots.

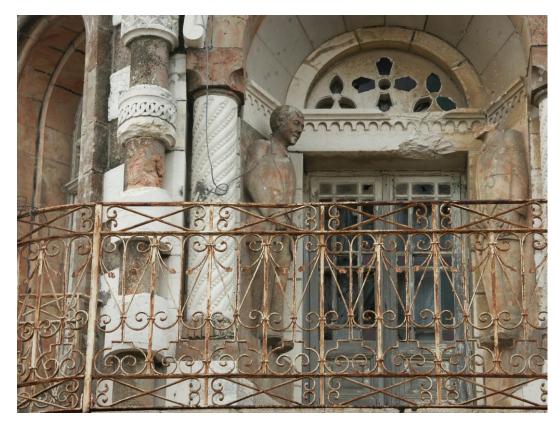
Dar Shawan in Beit Jala

The house is located in the higher area of Beit Jala, in front of the Gilo settlement. It is very particular. It has been built in 1917. It is rich in decoration and stone works. It suffered damages from shots in various parts of the façade. Shots created holes that reach 10-15 cm of diameter and are 7-15 cm deep. Old colored glasses of the windows have been broken. One of the statues of the main façade, the door architrave and the columns have been hit. Plaster and original painting inside two rooms have been damaged.
